YOUR PROFESSIONAL HOME INSPECTION REPORT
Interior Home Inspections

2107 SOMEWHERE ROAD

Brian Sanjenko AHI
Interior Home Inspections

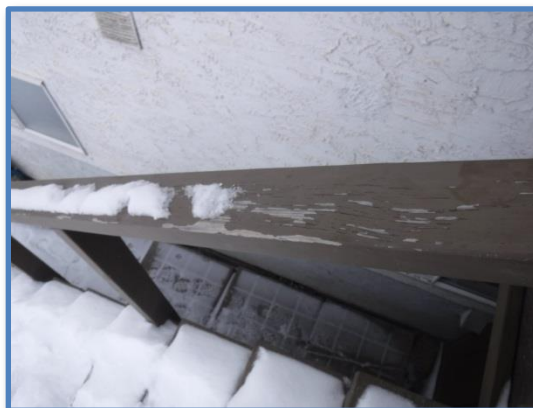
REPAIR NEEDED: Portions of the exterior woodwork and painted surfaces are showing deterioration to the paint/stain finish. It is important that these surfaces are kept well protected to ensure a maximum service life. The need for exterior painting is now indicated. Subsequent paint maintenance can be carried out as the usual signs of failure such as cracking, peeling or blistering of the painted surface become evident. Typically this would occur at intervals of five to seven years.

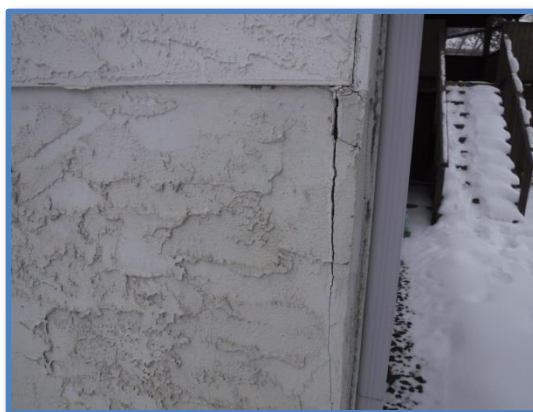
ATTENTION: The stucco cladding has cracks at various locations. It is not recommended trying to reseal cracks that are thinner than the thickness of a quarter, because the crack is too thin to hold repair material and will detract from the appearance of the finished surface. Cracks wider than the thickness of a quarter can be repaired with the same stucco formulation used to apply the cladding. However, if cracks return and are suspected to be caused by expansion/contraction of structural components, it may be necessary to use an elastomeric-type of sealant. Recommendation is to monitor the cracking and repair when appropriate.

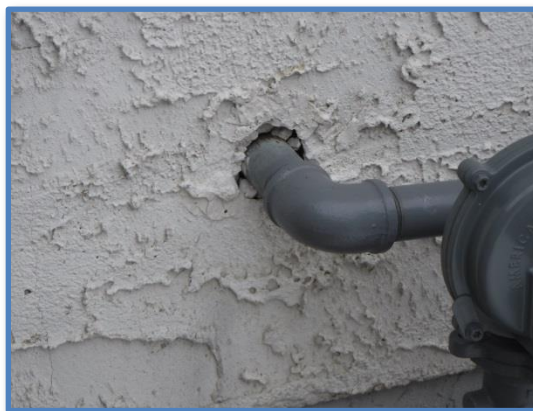
REPAIR NEEDED: There are one or more holes in the walls where penetrations go through the wall such as hose bibbs and vents. Some of these holes have not been properly sealed to prevent storm water from entering the home. Recommendation: Seal holes to prevent moisture infiltration.

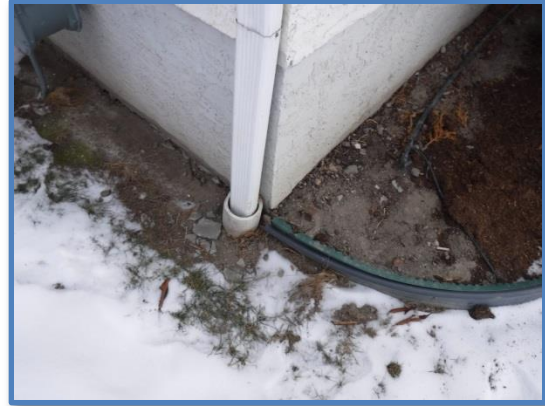
ATTENTION: There are planters that have been constructed around the perimeter of the home. Planters may look nice, but they are not a good idea to have against the home as it encourages bug entry as well as the potential to introduce water around the foundation and into the basement. I suggest removal of the planters, or filling them with decorative rock or gravel.

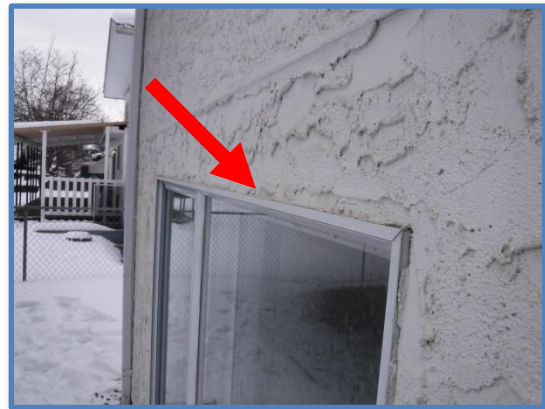
IMPORTANT: Weather exposed windows and doors must have a drip flashing installed. This flashing must be installed in such a way as to help prevent storm water from getting behind the siding and into the framing at the tops of windows and doors. Some of the weather exposed windows and doors on this home do not have such a flashing. I recommend installation of the required drip flashing by a licensed carpenter.

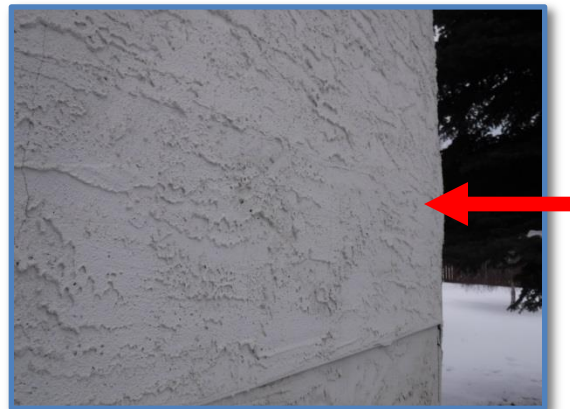
ATTENTION: The stucco on the exterior walls of this home is bulging at the floor joist line in one or more locations. This is most likely the result of the floor joists shrinking and drying out causing the stucco to bulge or bow out in the curing process. No repairs are needed unless the stucco cracks. Monitor and repair as needed.

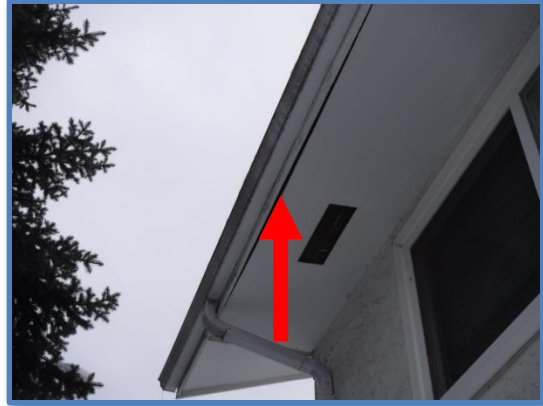
REPAIR NEEDED: There are one or more damaged soffit panels on the home. Recommendation: Repair damage to prevent insect and bird access.

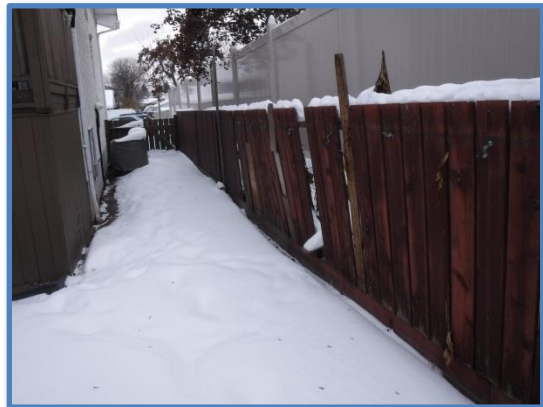
REPAIR NEEDED: The wood fences around the property are starting to weather and are due for painting or staining to help keep them looking good longer. Paint or stain as required.

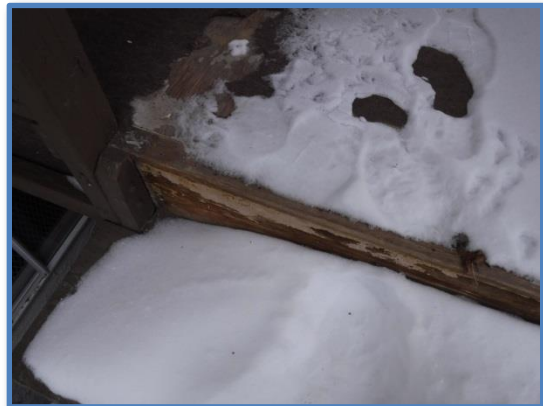
REPLACEMENT NEEDED: The back deck surface is covered with an indoor/outdoor type of carpet. Having carpet on a deck surface is a poor idea as it gets wet and then does not allow the deck to dry out. This encourages rot damage on weather exposed decks. Some of the carpet is damaged. I recommend replacing the carpet with a better alternative deck walk surface.

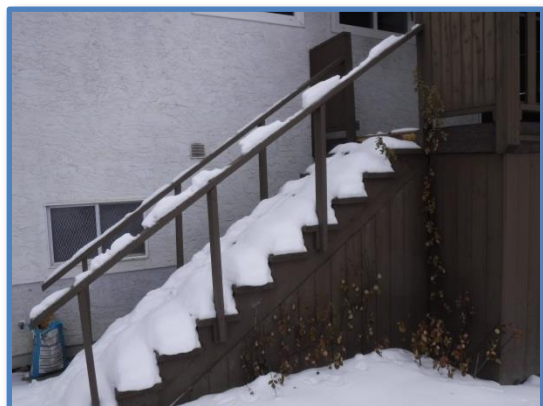
REPAIR NEEDED: The handrail for the back deck stairs is not safe as it does not conform to the required safety standards. The required spacing for a railing is no openings greater than 4 inches, and the railing must not

facilitate climbing. I suggest constructing safe railings by a licensed carpenter.

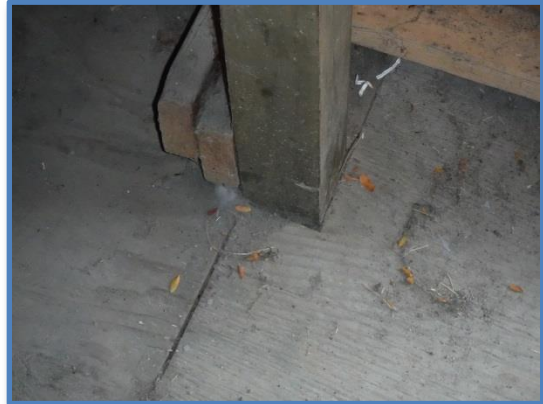
REPAIR NEEDED: The support posts for the back deck are undersized, and only one of them is sitting on a concrete foundation; the other posts appear to be buried in the ground, there may be concrete below the surface. Adding larger support posts would be a good improvement, as well as having all the support posts sitting above grade on concrete. Repair as needed by a licensed carpenter.

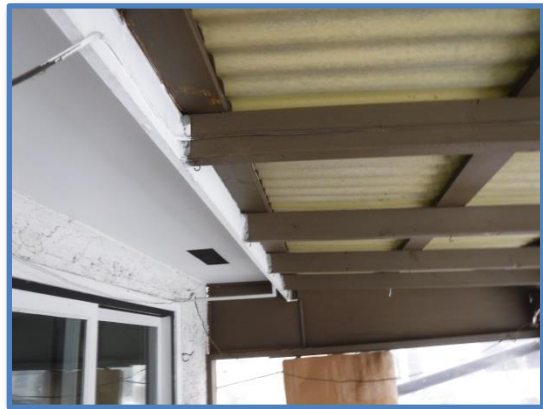
REPAIR NEEDED: The roof structure for the back deck is undersized, and is poorly attached to the house. The ceiling joists are 2 x 4, these should really be a minimum of a 2 x 6. The way the deck roof is attached to the house is poorly done as well, the rafters are supported by screws through a fascia board that hangs below the roof level of the home. Screws cannot be used in a horizontal plane to support structural members, and the way the fascia board is used to support one end of the deck roof is undersized and poorly supported. Redoing this deck roof structure will be required sooner rather than later.

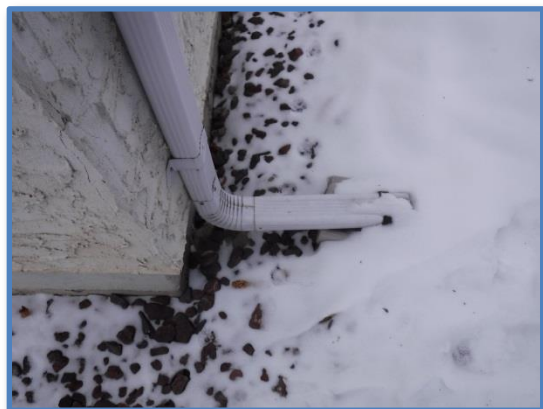
REPAIR NEEDED: One or more of the gutter downspout(s) for the home terminate directly next to the foundation. A proper configuration has the downspout(s) terminating at least 6-feet away from the foundation. Recommendation: Repair as appropriate.

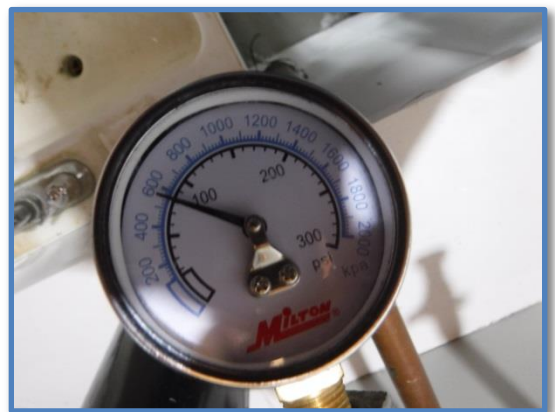
REPAIR NEEDED: The water pressure coming into the home is in excess of 80 pounds per square inch. Normal water pressure is considered to be 30 to 60 pounds per square inch. Recommendation: Installation/replacement of a pressure reducer valve by a licensed plumbing contractor in order to avoid damage to the interior plumbing system.

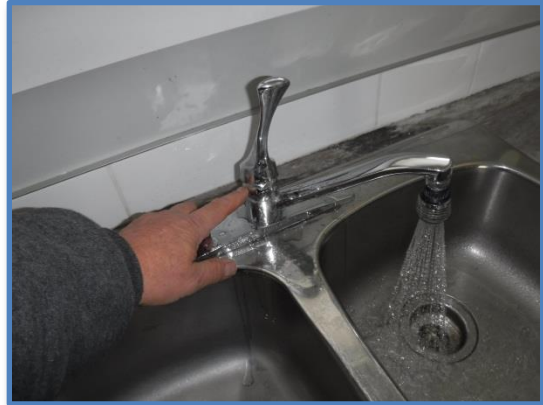
REPAIR NEEDED: The faucet at the kitchen sink leaks when operated. Recommendation: Repair or replacement by a licensed plumbing contractor as appropriate.

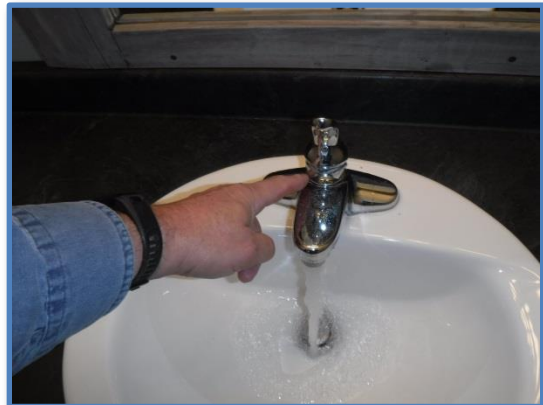
REPAIR NEEDED: The faucet at the hall bath sink leaks when operated. Recommendation: Repair or replacement by a licensed plumbing contractor as appropriate.

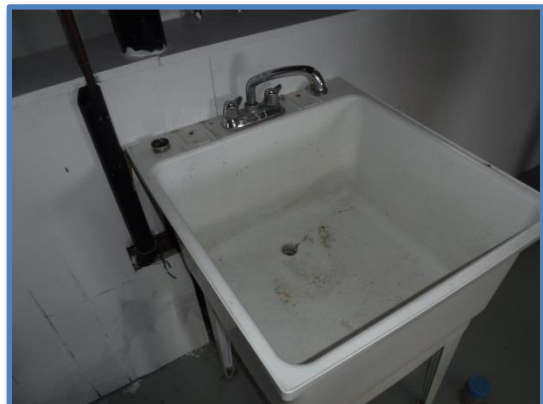
REPAIR NEEDED: the faucet at the laundry sink leaks when operated and the laundry tub also has a slow drain. Recommendation: Repair or replacement by a licensed plumbing contractor as appropriate.

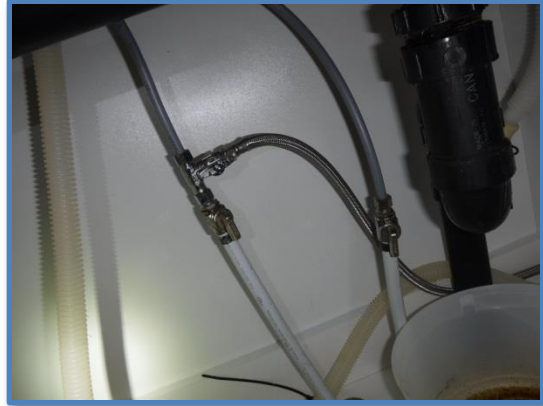
REPAIR NEEDED: The trap/drain beneath kitchen sink appears to leak. Recommendation: Repair as appropriate by a licensed plumbing contractor.

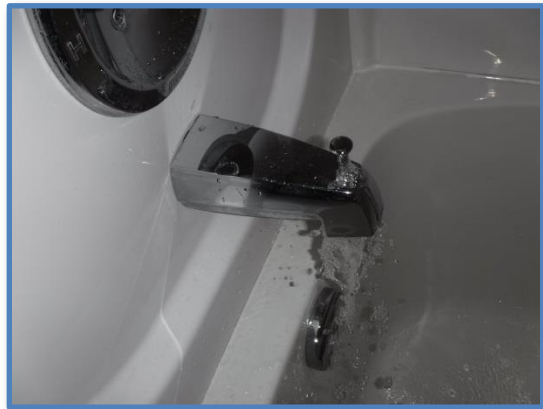
REPAIR NEEDED: The diverter spout at the tub/shower in the hall bath leaks or will not function properly and needs to be repaired or replaced.

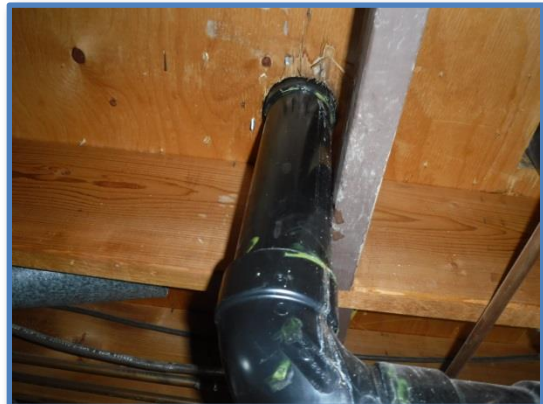
REPAIR NEEDED: There is evidence of water beneath the floor covering around the toilet in the hall bath. This is typically the result of a failed wax seal where the toilet pedestal mounts to the main soil pipe and often causes a bathroom subfloor to rot and need replacement. It should be noted as well that when the hall toilet is flushed there is a virtual cascade of water down the exterior of the drain pipe in the basement. Recommendation: Remove toilet, inspect soil pipe collar, replace if rusted and weak, install new wax seal and re-install toilet as appropriate; please note that the floor tiles will need to be lifted in order for timely drying of the subfloor to occur. Work should be done by a licensed plumbing contractor and tile setter.

REPAIR NEEDED: I found indications of water beneath the floor covering around the toilet in the hall bath. This is typically the result of a failed wax seal where the toilet pedestal mounts to the main soil pipe and often causes a bathroom subfloor to rot and need replacement. I recommend immediate further investigation and repairs as necessary and appropriate.

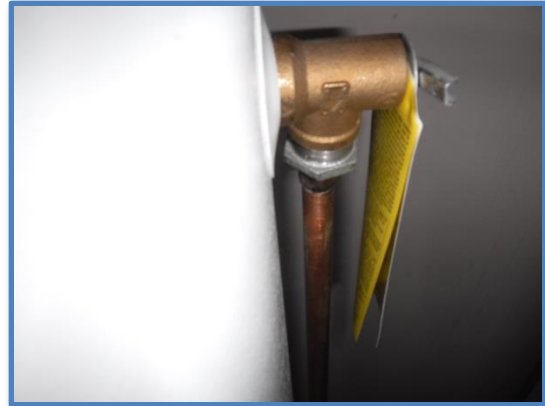
DANGEROUS: REPAIR NEEDED: The discharge pipe for the temperature pressure relief valve is too small. The pipe must be the same diameter as the valve (3/4 inch), installing a pipe of smaller diameter creates a "bottleneck" effect and can cause a steam explosion should the valve release pressure. Have a licensed plumber install the properly sized discharge pipe.

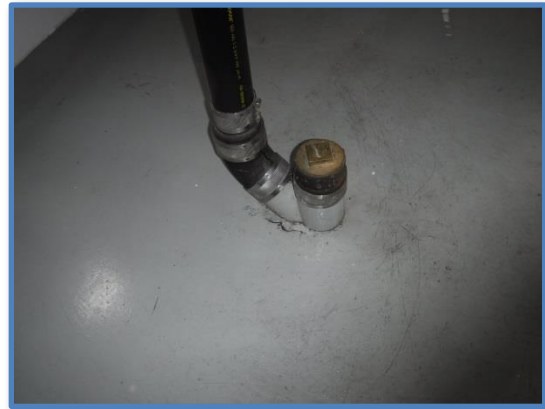
ATTENTION: Some of the drain lines in the home are cast iron and are probably at the end of their service life. The service life for cast iron is 30-35 years. Newer construction methods require the fitting of schedule 40 ABS plastic drains. Recommendation: Due to the age of the home, a further inspection of the drain line from the house to the street using a fiber optic closed circuit camera is probably prudent. If the outcome of the further inspection is not satisfactory, then replacement of all cast iron to the 4-inch main at the street by a licensed plumbing contractor is recommended.

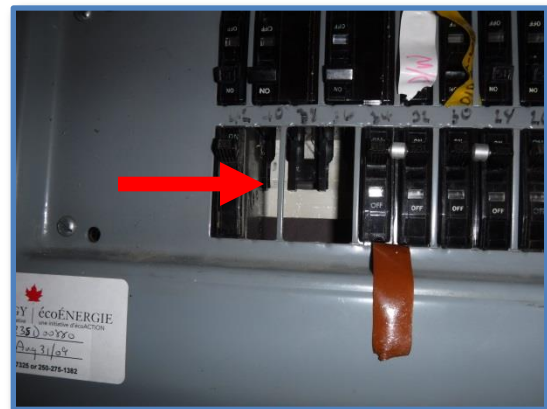
REPAIR NEEDED: The electrical service panel has a hole or holes in the panel box. The hole(s) is likely the result of a previous line from an appliance being removed. Recommendation: Box holes no longer in use need to be plugged in order to keep out insects and small rodents. Plugs necessary are available at most electrical supply stores.

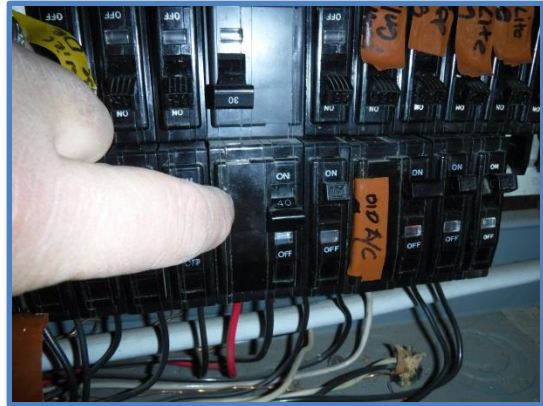
REPAIR NEEDED: There are breakers/fuses in the service panel that are rated for more than their associated circuits require. This is known as overfusing. Overfusing can allow more loads on a branch circuit than the wiring is rated for, overheating conductors and leading to electrical fires. The breaker in this case, is associated with the dryer circuit. Recommendation: Repair as appropriate by a licensed electrical contractor.

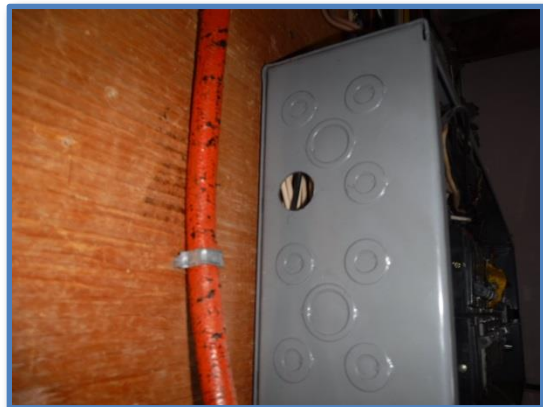
REPAIR NEEDED: There are open cable openings in the sides of the service panel box where cables may have been removed. When wiring is removed from a panel, these openings are supposed to be plugged with approved devices. I recommend having this corrected by a licensed electrician.

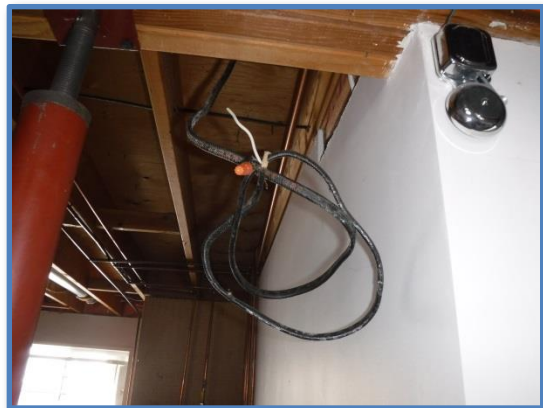
REPAIR NEEDED: There are electrical wires in the basement that have been improperly terminated. Even though the wires may not be live, they need to be terminated in an approved junction box, capped and taped so that if they inadvertently become powered they will not electrocute anyone or start an electrical fire. Repair by a licensed electrician is required.

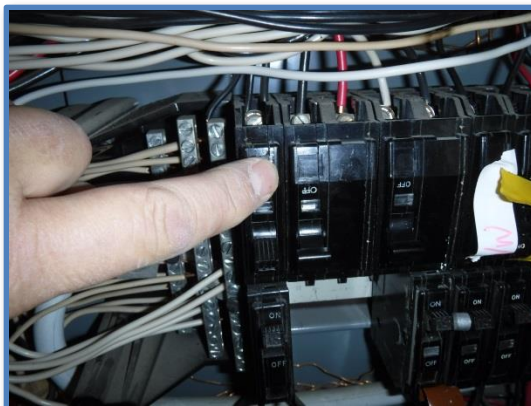
DANGEROUS: There are one or more conductors connected to fuses/breakers in the main service panel that is too small for the required load the circuit and associated breaker will subject it to. Wiring that is too small will be prone to overheating and this can result in electrical fires, the conductor in question is for the electric range in the kitchen. I recommend immediate evaluation and rewiring as necessary by a licensed electrician.

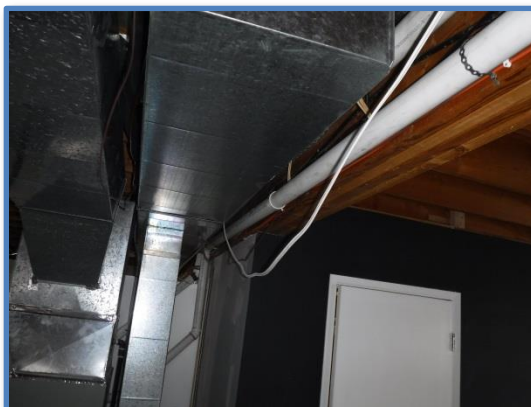
REPAIR NEEDED: There is an electrical cable that is inadequately supported. Metal Clad cable must be supported at intervals not exceeding 6ft, while Non-metallic Sheathed Cable (NM or NMC) and Armor Cable (AC or BX) must be supported at intervals not exceeding 4½ft. In every case, these cables must be secured within 12 inches of boxes or panels where they terminate. Cables should closely follow building surfaces and need to be secured with proper fasteners. When NM cable is installed perpendicular to and on top of or beneath framing members, it must be secured to running boards. I recommend that an electrician make corrections as needed.

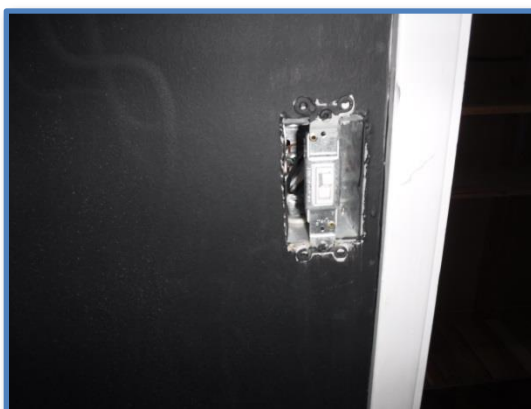
REPAIR NEEDED: There is one or more outlet/switch covers missing for wall outlets and or switches in various locations throughout the home. Recommendation: Install proper covers as required as this is a shock hazard.

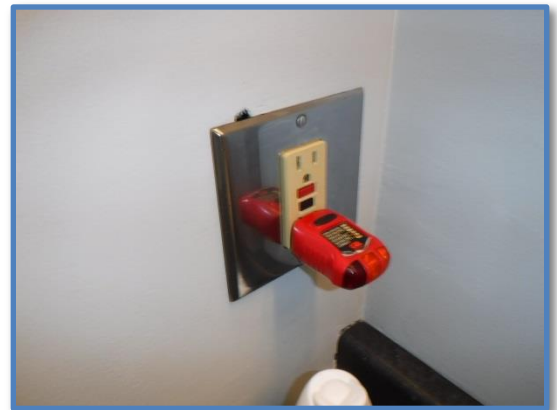
REPAIR NEEDED: The GFCI outlet in the main bathroom does not trip when a ground fault is artificially introduced. Recommendation: Repair as appropriate by a licensed electrical contractor.

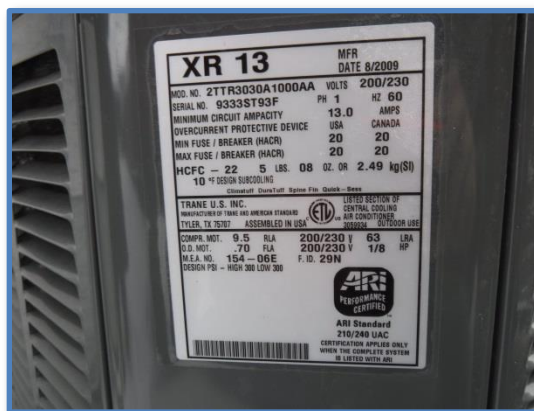
IMPORTANT: Please note that this air conditioning unit is charged with the R-22 refrigerant. In 2008/2009 they stopped making the R-22 refrigerant; if this system needs to be re-charged at any time it may be difficult to obtain the R-22 refrigerant. If this happens, then replacing the unit would most likely be required.

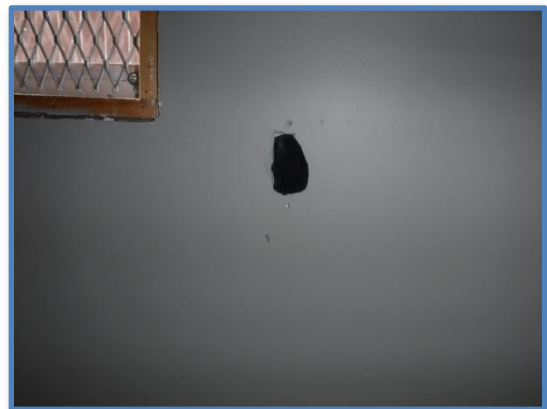
REPAIR NEEDED: There is a hole in the wall in the north basement. Recommendation: Repair and paint as appropriate.

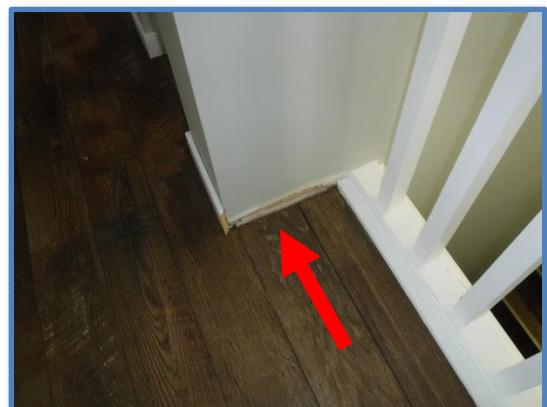
REPAIR NEEDED: There is missing floor trim in the home. Recommendation: Repair or replace as appropriate.

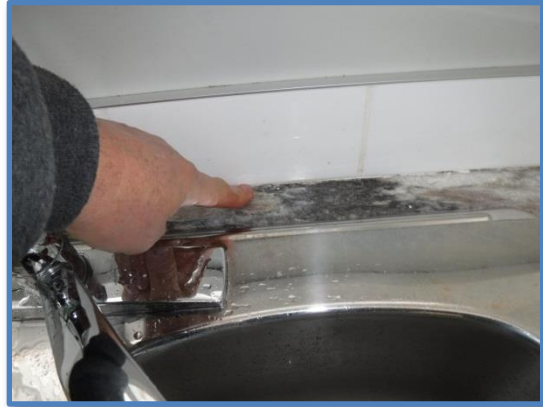
REPAIR NEEDED: Some of the bathrooms, kitchen and laundry room need to have the backsplash caulked to prevent water from getting behind the cabinets. Caulk as required.

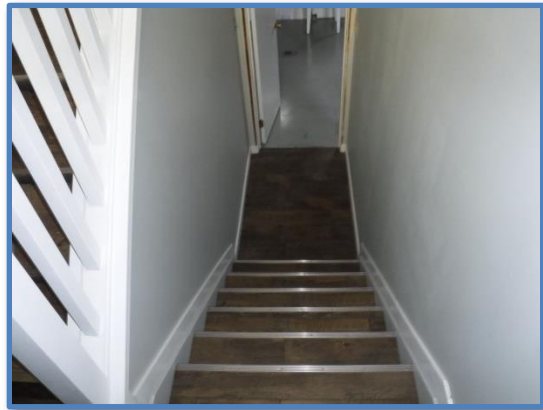
REPLACEMENT NEEDED: The required handrail to the basement stairs is missing. Have an approved handrail professionally installed.

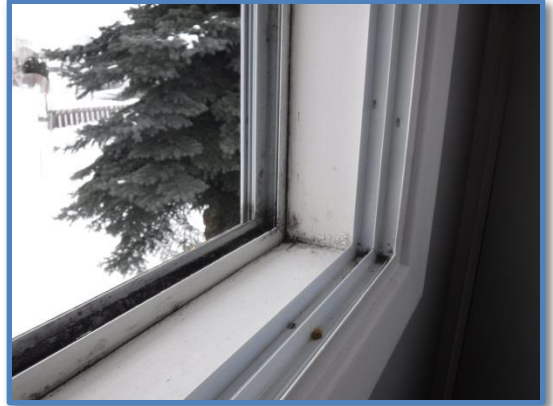
ATTENTION: Some of the existing window frames and sash are to an older standard; I recommend the client consider upgrading to modern, double or triple-paned windows. Consult a professional window installer to discuss options and cost.

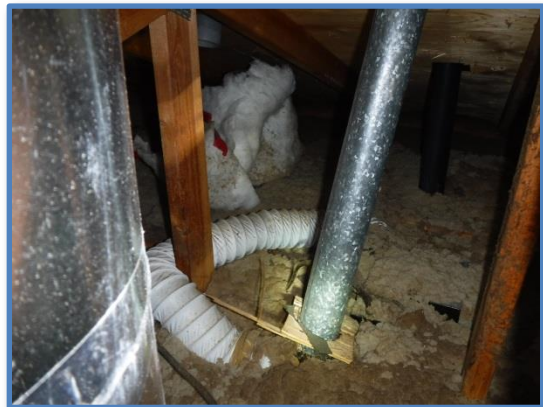
REPAIR NEEDED: The ductwork for the hall bathroom exhaust fan is uninsulated in the attic. The ductwork is also poorly installed, and a section of it is undersized. I recommend removing the ductwork from the fan and installing new 4 inch diameter ductwork that is wrapped in insulation as required. All work should be done by licensed professionals.

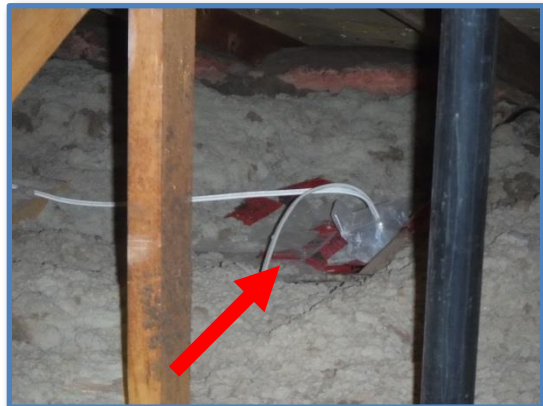
REPAIR NEEDED: The exterior walls and ceilings were scanned with an infrared camera in order to determine if areas of insulation were missing or deficient. It was found that there is insulation missing in the attic above one of the kitchen light fixtures. Adding additional insulation to this area is required to prevent heat loss from the home. Have a licensed insulation contractor repair as needed.
