YOUR PROFESSIONAL HOME INSPECTION REPORT
Interior Home Inspections

2107 SOMEWHERE ROAD

Brian Sanjenko AHI
Interior Home Inspections

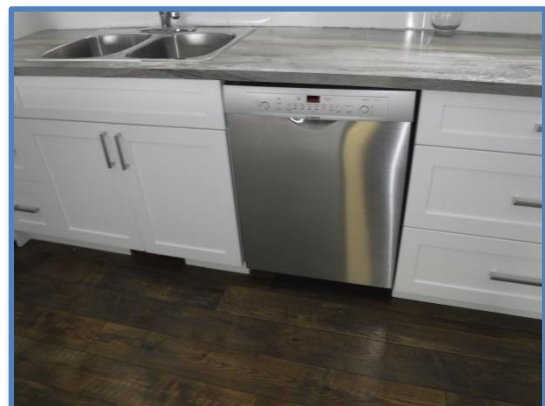
ATTENTION: The dishwasher is not sitting square in the cabinet opening. I recommend adjusting the dishwasher leveling legs to help it sit more square to the opening.

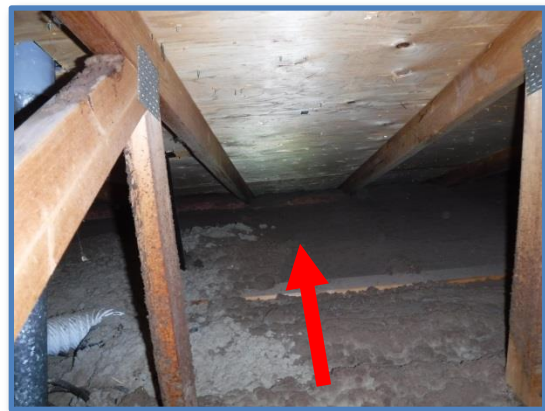
IMPORTANT: Some or all of the soffit intake vents were blocked with insulation, preventing adequate ventilation to the attic space. It is necessary to keep all vents clear so any infiltration into the attic spaces by moisture-laden air from the home can dissipate. Otherwise, moisture-related damage to the roof framing, sheathing or other components may occur. If any such issues were found, they will be enumerated elsewhere in this report. Having the intake vents cleared of obstructions is recommended. This may require the installation of baffles between the rafters to prevent blockage.

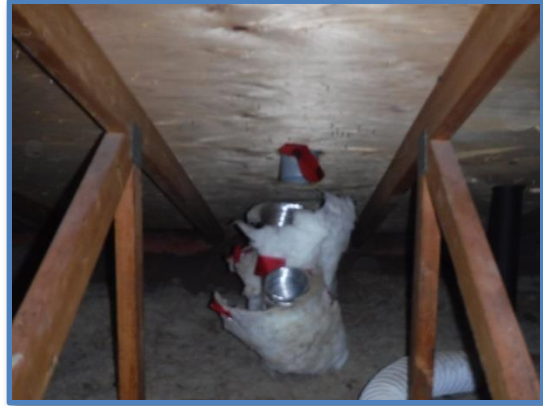
REPAIR NEEDED: The ductwork for the kitchen exhaust fan where it passes through the attic has fallen off of the roof jack, and is damaged. I recommend repairs by a licensed HVAC technician. At this point it is not critical for immediate repair as there is no kitchen exhaust fan installed. However when a fan is installed, the ductwork needs to be repaired; it must be insulated, have free flow, and be connected to the roof jack properly.
